Rapidan StreamSweepers 2013

Orange County Line to Madison Mills

Report to Landowners
and
Friends of Rapidan StreamSweepers

By
The Center for Natural Capital

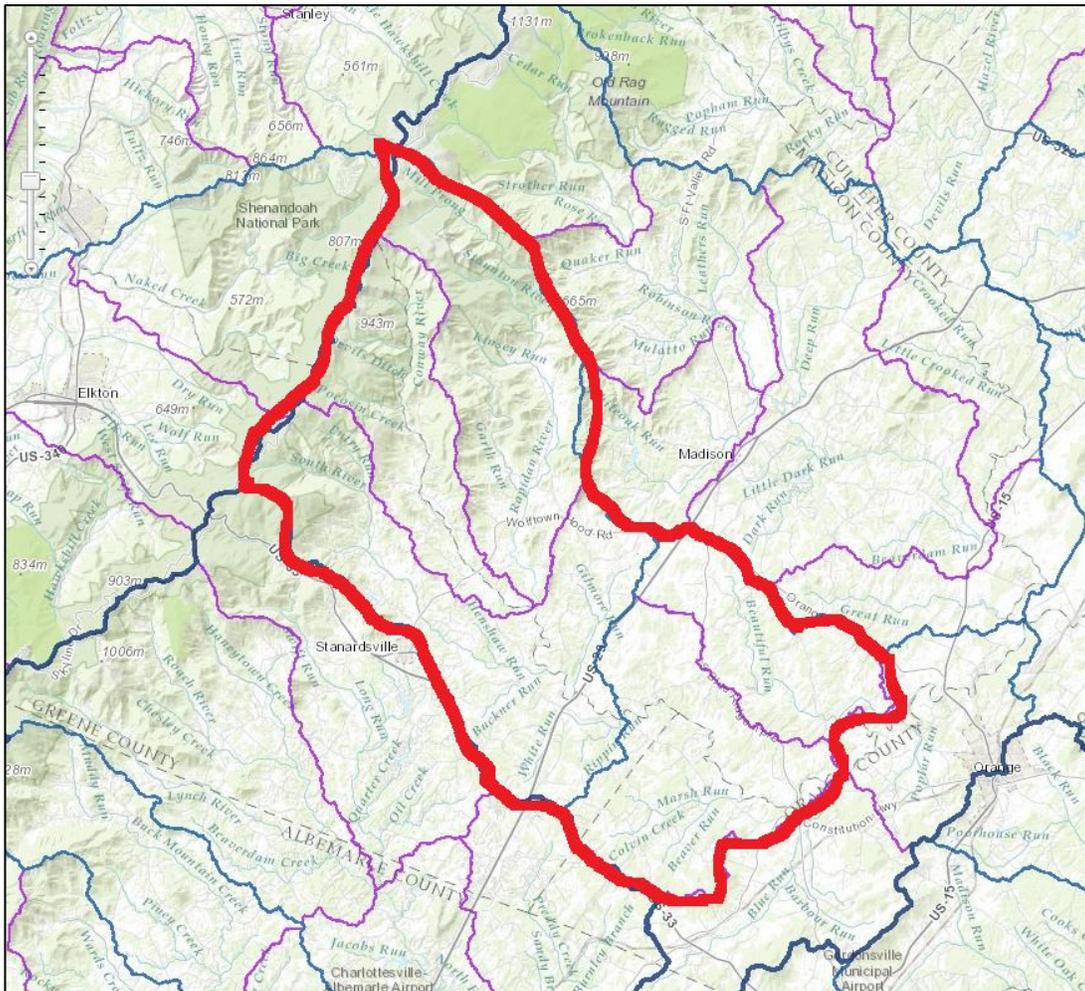
Figure 1 – Rapidan Segment Headwaters

The majority of the headwaters of the segment is found in Greene and Madison Counties. This area is comprised of five subwatersheds (Figure 1); Rapidan River Garth Run,

Rapidan River Marsh Run, Conway River, Beautiful Run, and Rapidan River South River. Note that the Robinson River watershed drains below this segment and thus is not a contributing sub-watershed.

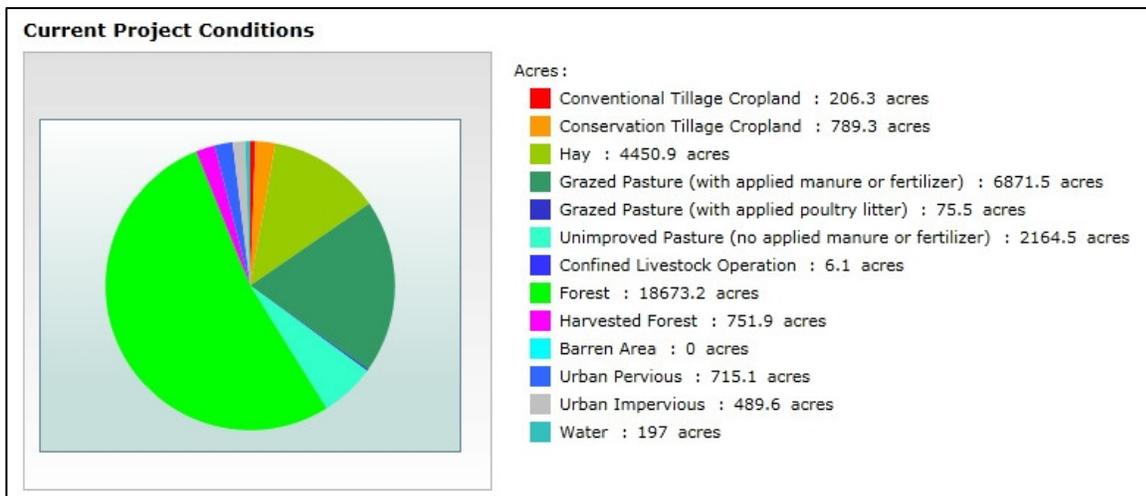
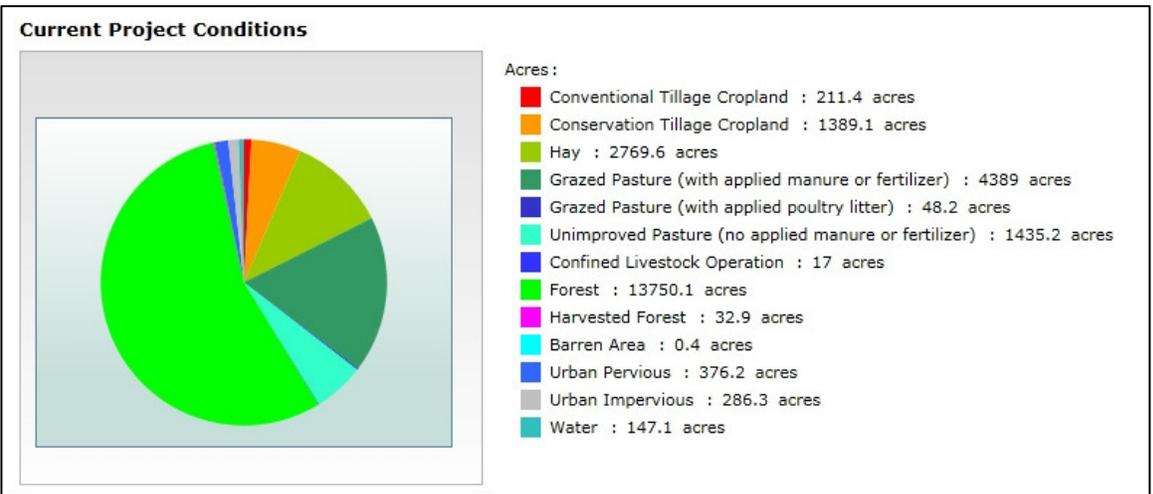
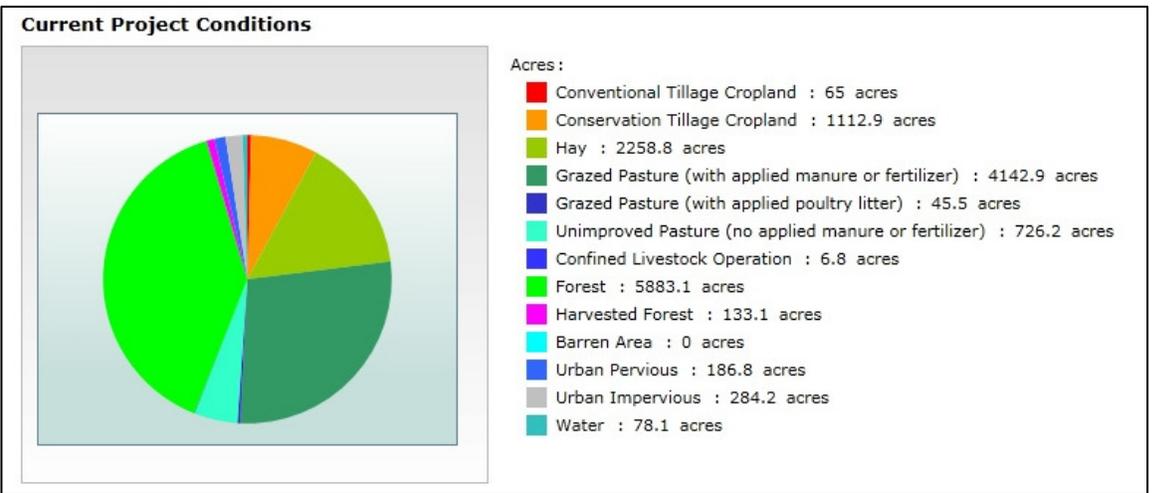
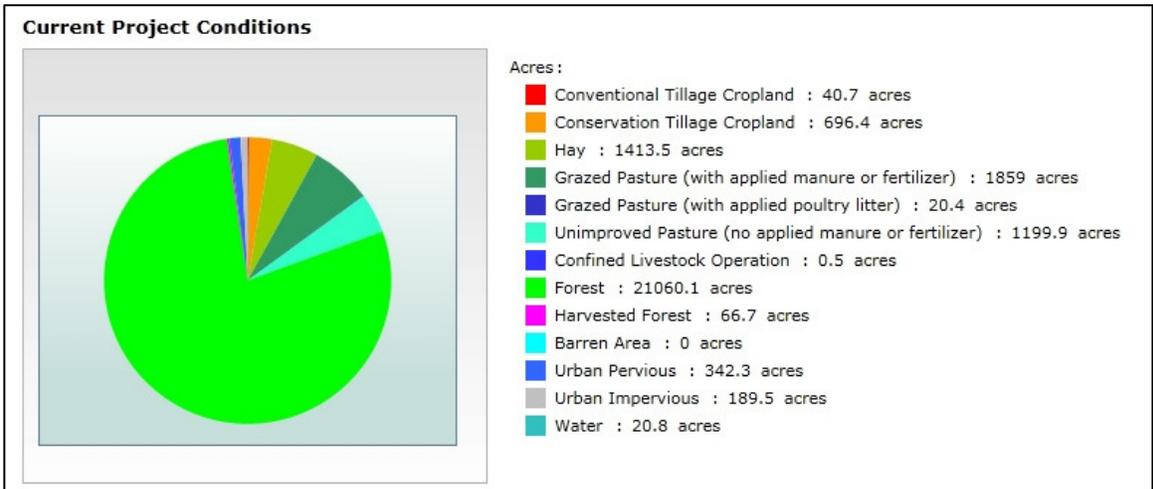
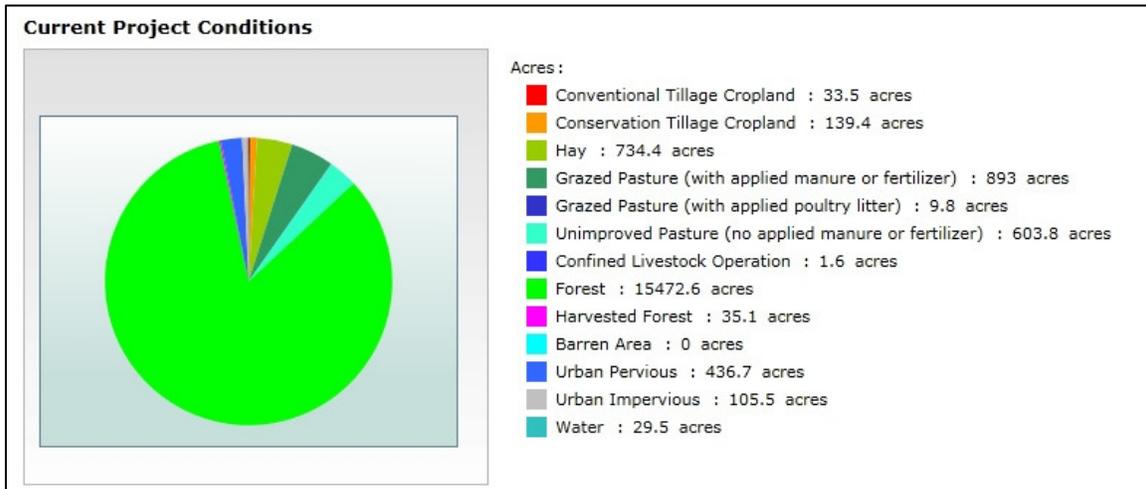
The current landcover for each subwatershed is shown below (Figures 2, 3, 4, 5, and 6) (www.inforest.com). The Conway River watershed has the largest proportion of forest cover. Rapidan River Beautiful Run has the largest proportion of Grazed Pasture with applied manure or fertilizer. Rapidan River Marsh Run has the most tillage. Rapidan River South River has the largest proportion of urban pervious land cover.

Table 1 shows the total acreages for the major land cover classifications. 63% of the area is forest, with 10% hay, 15% improved pasture, and 5% unimproved pasture.

Figure 2 – Rapidan River South River

Figure 3 – Rapidan River Marsh Run

Figure 4 – Rapidan River Beautiful Run

Figure 5 – Rapidan River Garth Run

Figure 6 – Conway River

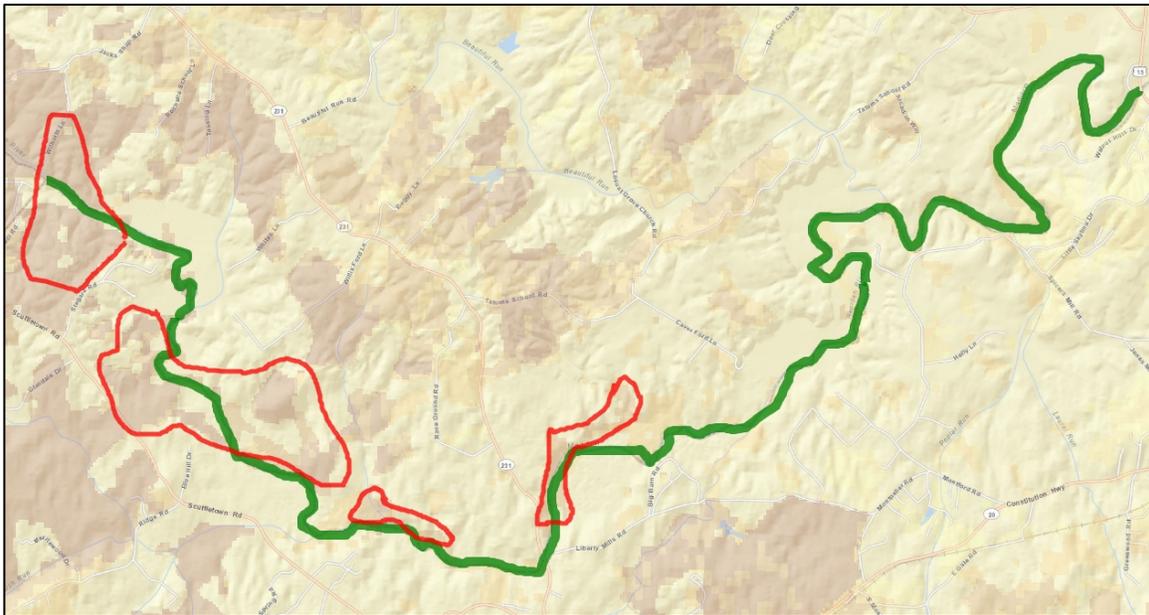
Figure 7 – River Segment Forest Conservation Value

The Virginia Department of Forestry has established a relative Forest Conservation Value (FCV) for all forestland in the state. This value is based on the level of benefits provided by a particular area of forest in combination with the level of threat the area faces from conservation to another land use, primarily development. Figure 7 shows four portions of the segment (circled in red) with high forest value; Stegara Road area on both sides of the river, Ridge Road intersection with Scuffletown Road on both sides of the river, an area slightly downstream of this on the Madison side of the river, and an area just east of Rt. 231 on both sides of the river.

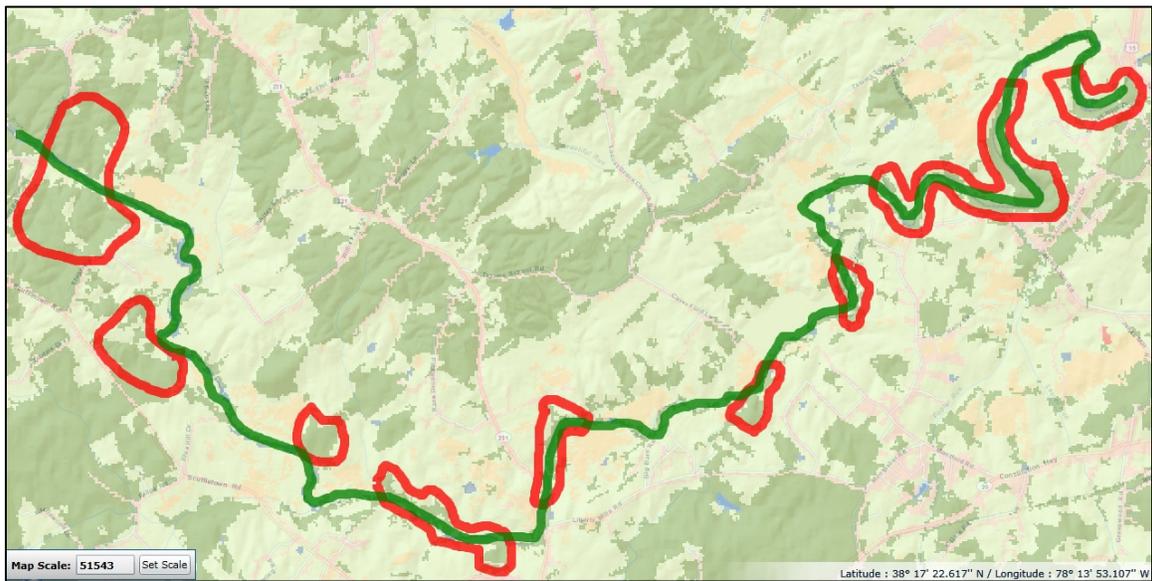
Figure 8 – Areas along the river segment with significant forest cover

Figure 8 shows land cover along the river segment. Portions circled in red have significant forest cover along one or both sides of the river.

- Figure 8 shows the areas with substantial forest cover along the river. A significant proportion of areas adjacent to the river has little to no forest cover. Absent any regulatory influence, how could landowners somehow work together to create conditions that might favor growth of a higher % of forest buffer along the river?

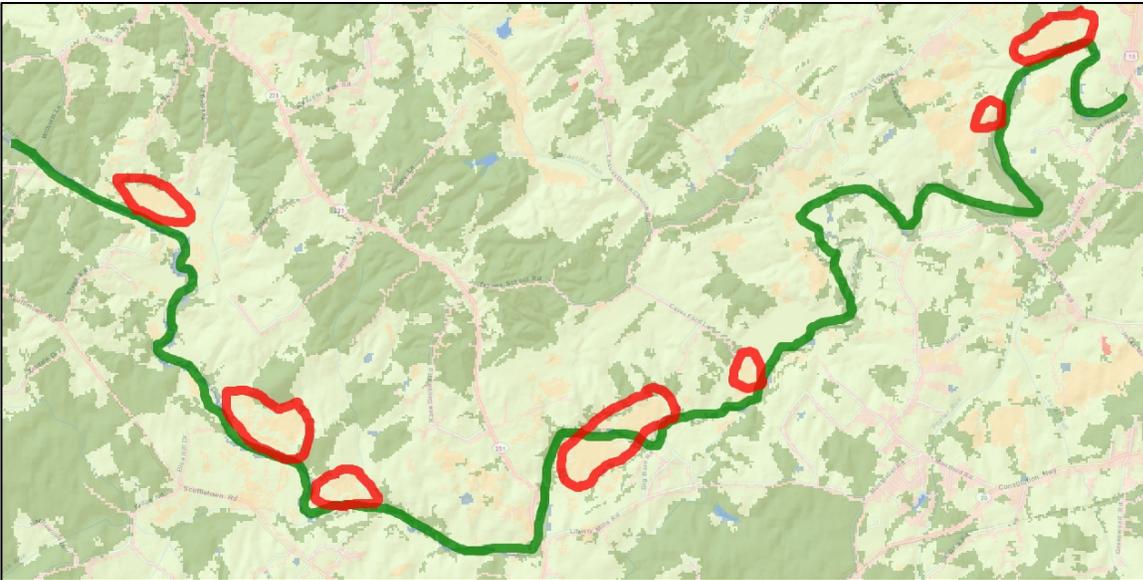
Figure 9 – Areas along the river with significant cultivation

Figure 9 shows areas circled in red with extensive cultivation up to the river bank.

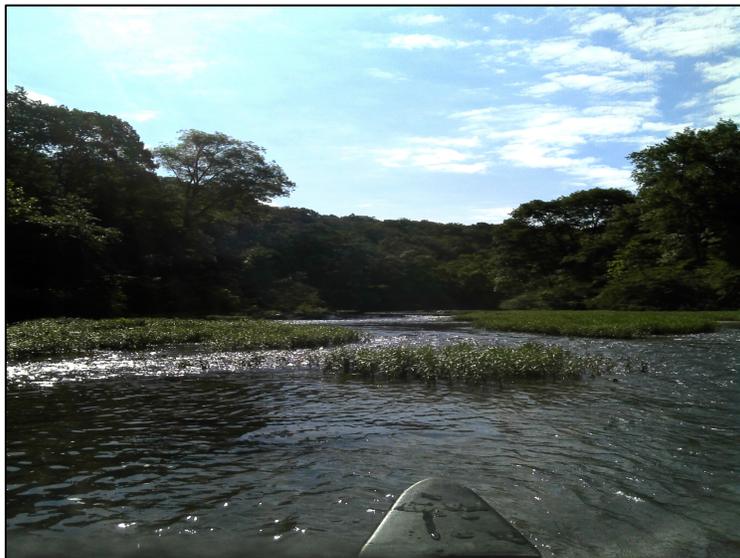
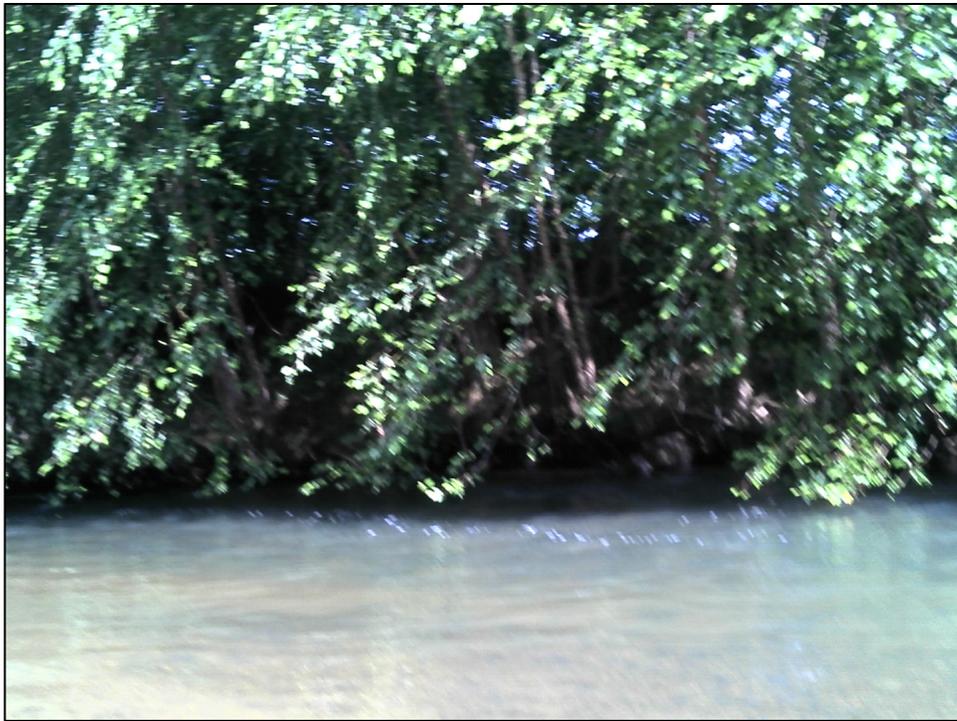
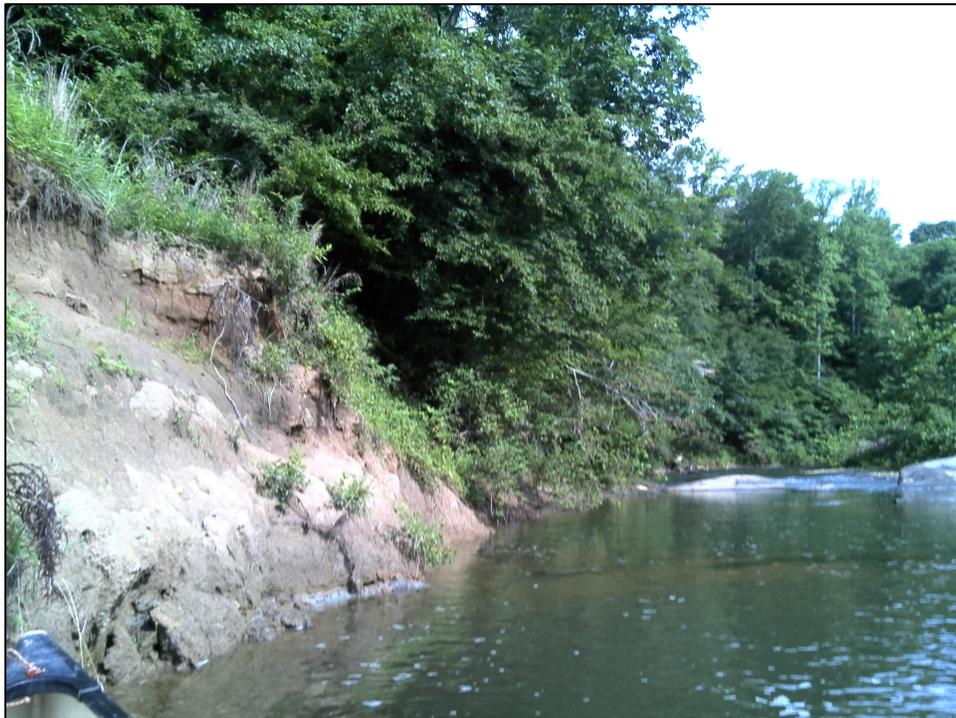
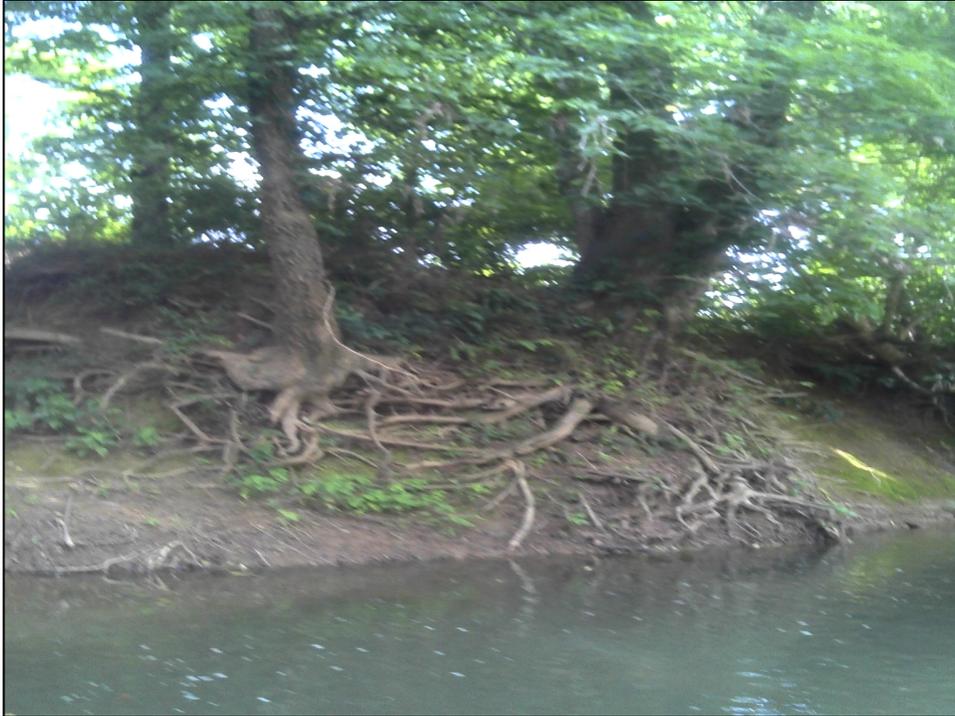
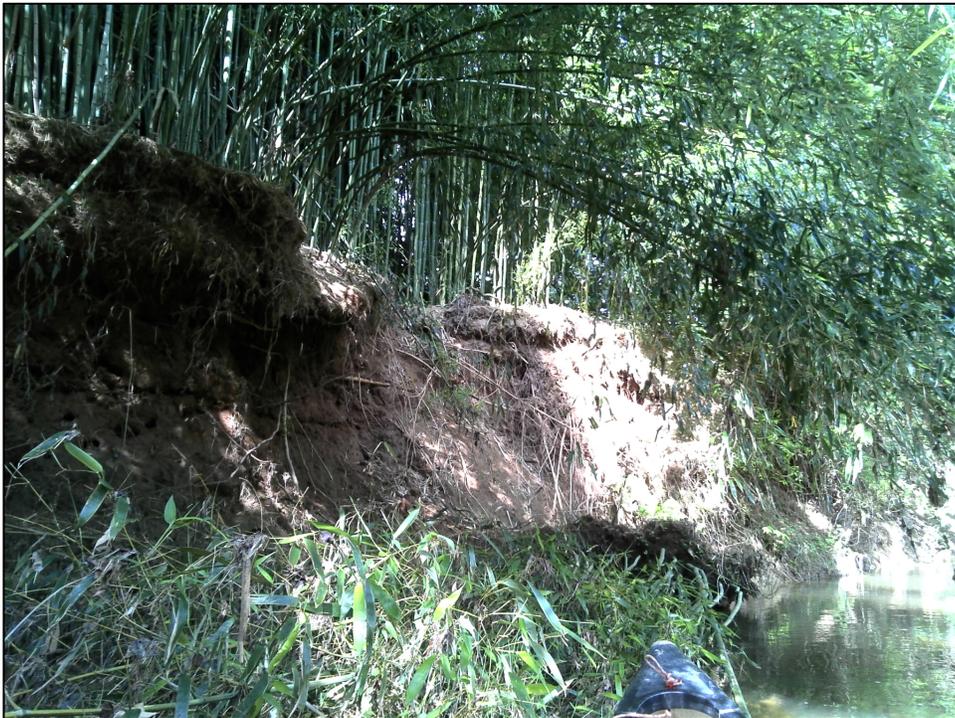
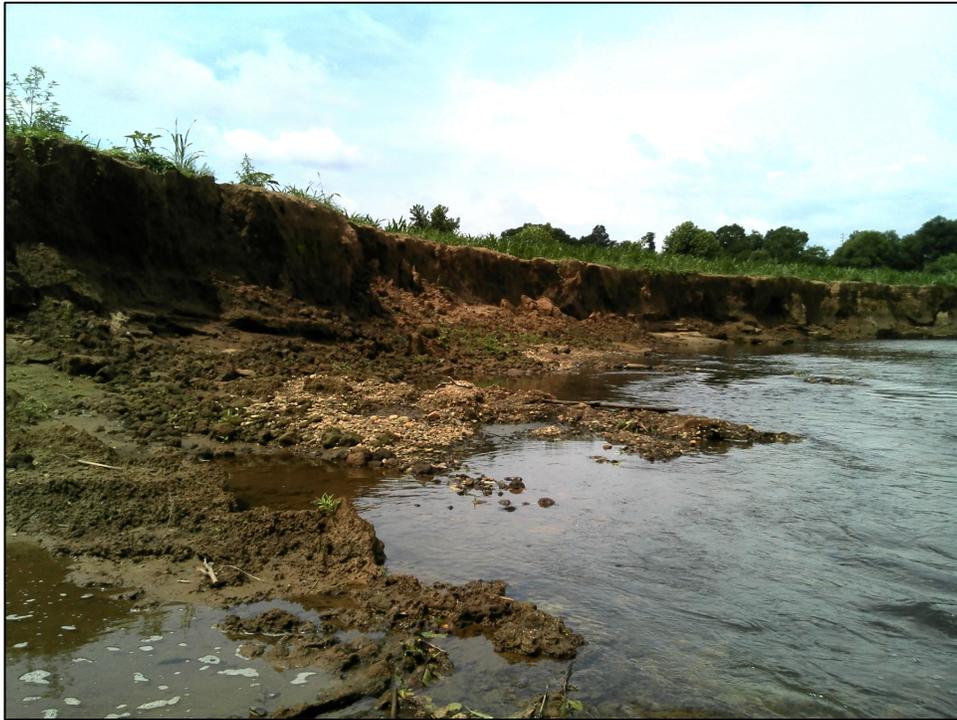
Figures 10-16 show the appearance of river bank in areas with difference degrees of forest and cultivated land cover. Note that soil loss occurs to some degree on any river bank surface, and much sediment in the river is from land use activity that occurred decades and centuries ago.

Figure 10 – Deep forest cover both sides river

Figure 11 – Native river birch on bank

Figure 12 – Transition from forest to cultivated

Figure 13 – Birch roots holding bank

Figure 14 – Bamboo on bank

Figure 15 – Cultivated cover on bank

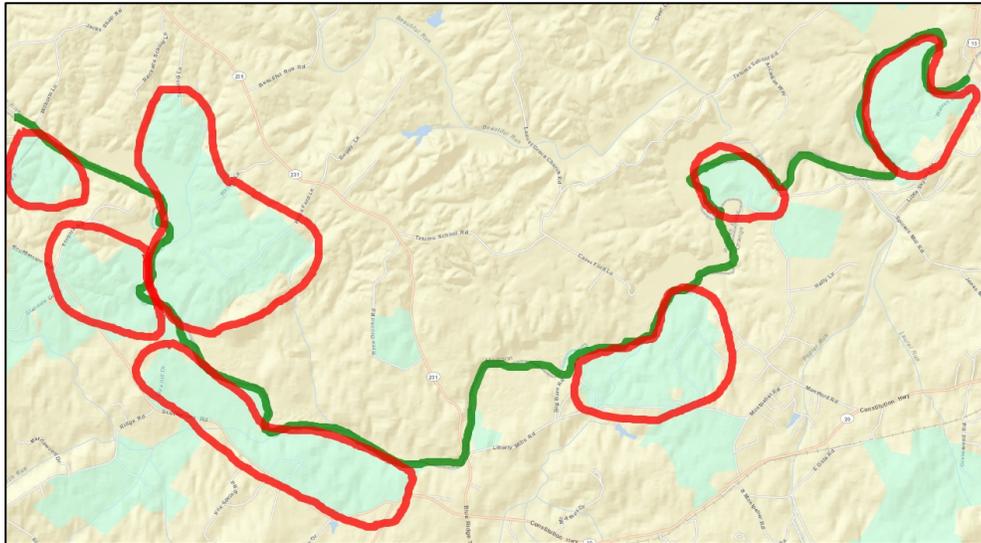
Figure 16 – Eased Lands along the River

Figure 10 shows the location of permanently conserved lands along the river.

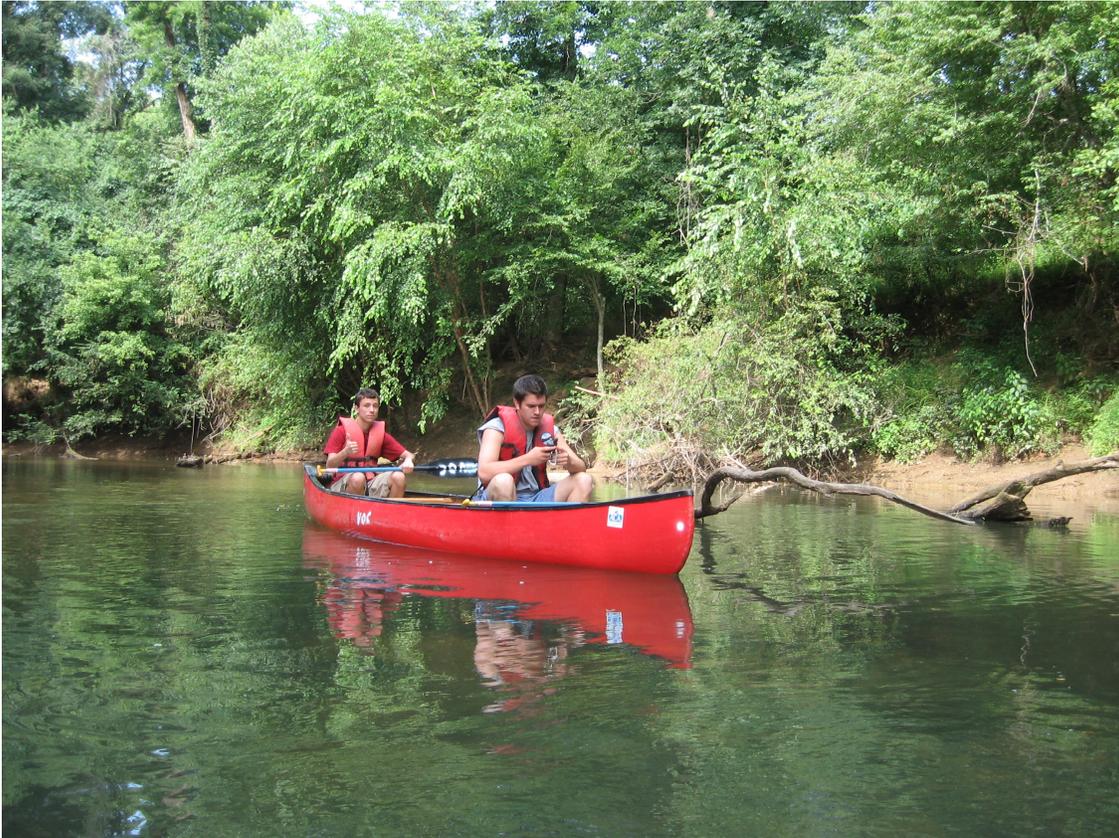
Figure 20 – Sweepers working as a team to screen River Health

Sweepers conducted a “screening” of the 17 mile river stretch. Two Sweepers worked as a team in a canoe, with one person observing and calling out assessment ratings, while the other person recorded the information on the handheld Garmin GPS (Figure 14). The purposes of the screening included the following objectives:

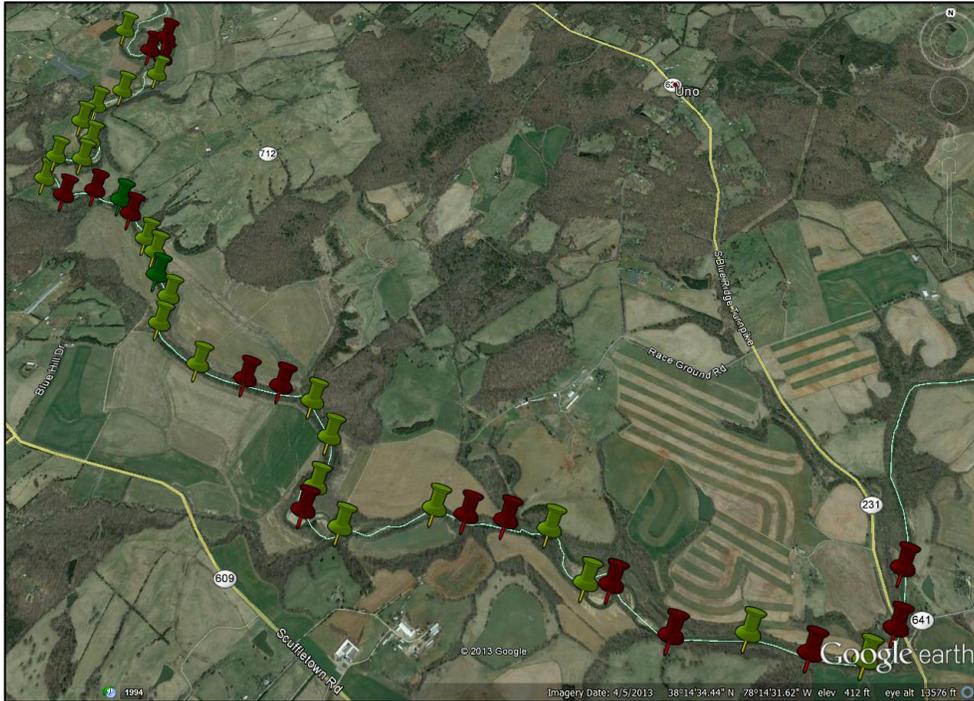
Figure 21 – Section 1 Madison Side

Note that much of this section is rated as low or moderate, with the exception of an area about 1/3 of the way down. The Orange side of this same section is shown below.

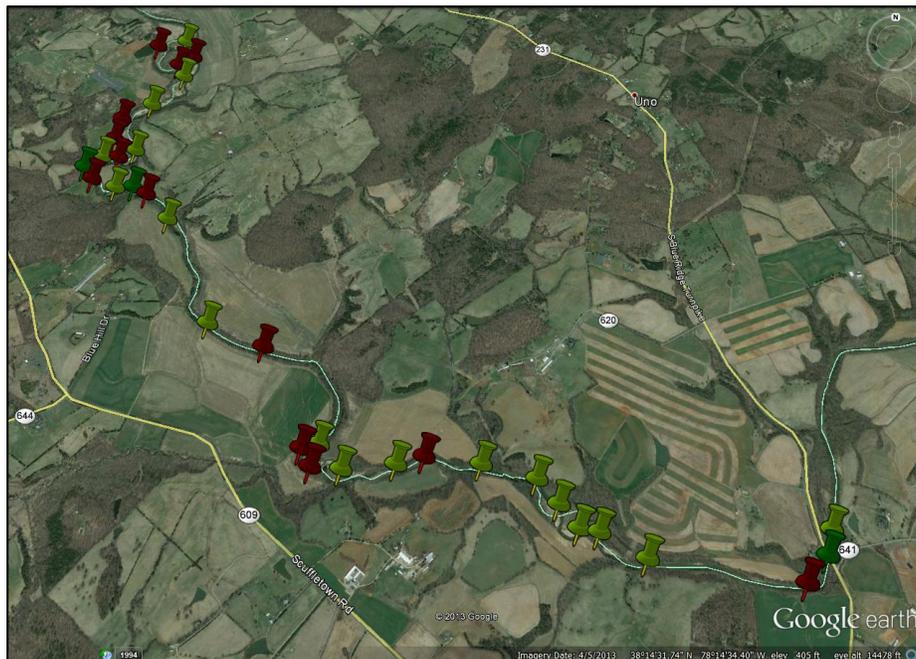
Figure 22 – Section 1 Orange Side

Note that with the exception of the area around 231 rated as high, most of this section is also rated as low or moderate. Section 2 Madison results are shown in Figure 17 below. Note that with the exception of an area ¼ of the way down the stretch, most of this area is rated low.

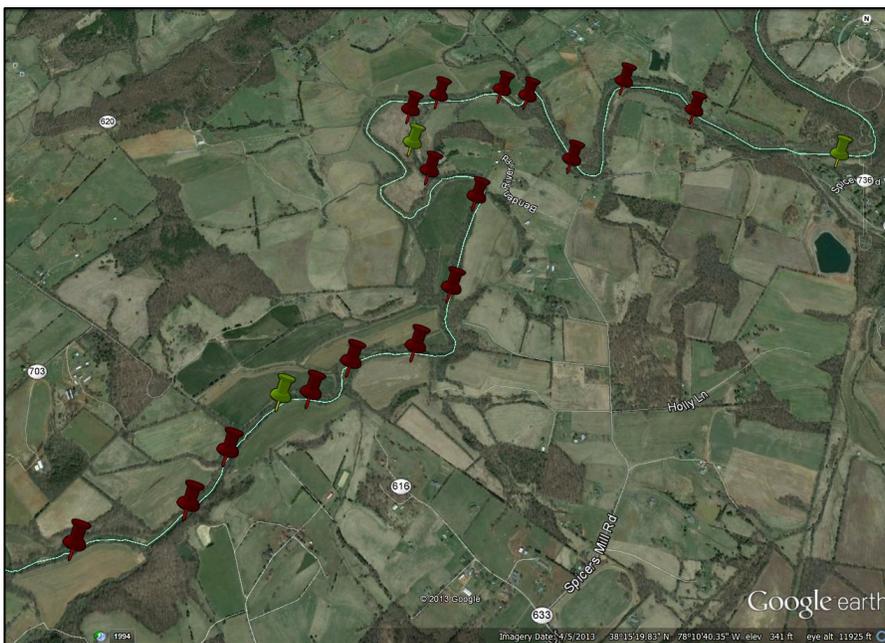
Figure 24 – Section 2 Orange Side

Section 2, Orange side of the river screening results, are shown in Figure 18 below. With the exception of the three areas rated moderate, each a third of the way down the river, all of this section is rated as low.

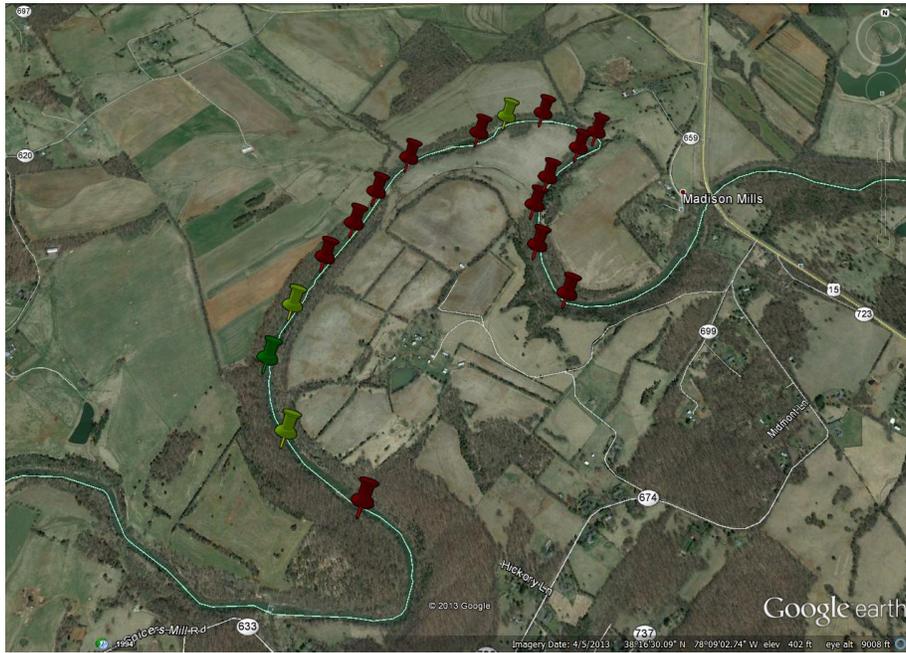
Figure 25 – Section 3 Madison Side

Section 3, Madison results are shown below in Figure 19. Note the moderate and high results at the beginning of the stretch and the lower results toward the end.

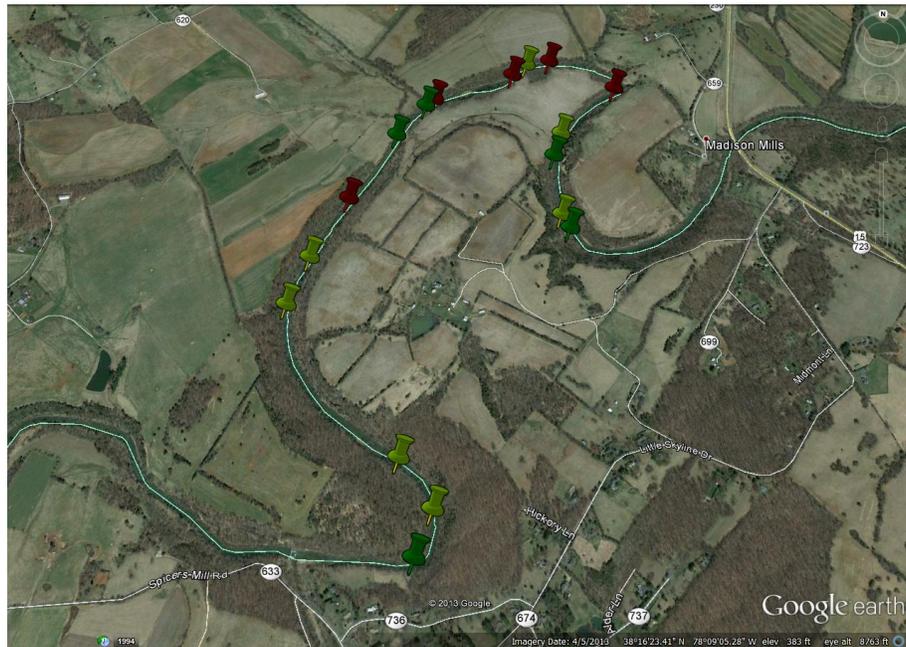
Figure 26 – Section 3 Orange Side

Finally, the Section 3, Orange side is shown below in Figure 20. Note the moderate to high quality of the beginning and end of this section of river.

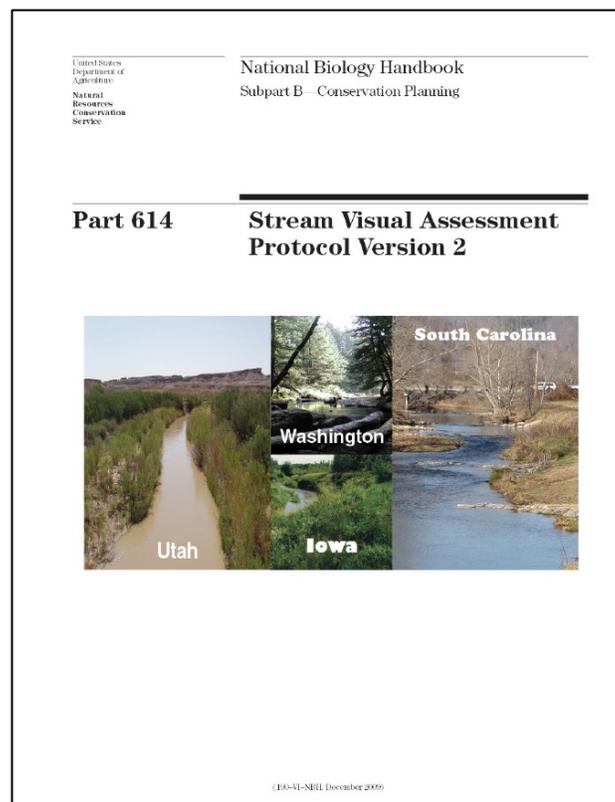
Figure 27 – USDA Protocol

The screening is a rapid, qualitative assessment of river condition based on a USDA Stream Assessment Protocol (Figure 21).

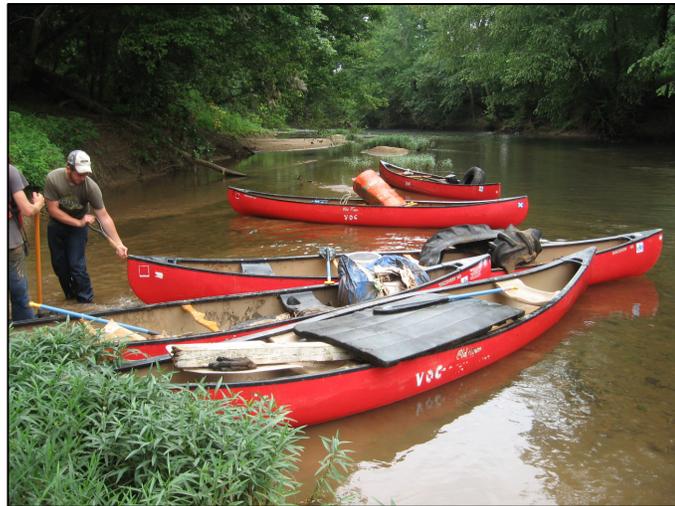
Figure 29 – Canoes used as garbage barge

During the assessment and diagnostic stage of the project described above, Sweepers took GPS coordinates of concentrations of tires and other large debris. Landowners were contacted to secure trash removal access points and boat put in/take out at several locations throughout the 17 mile stretch. Based upon observation, the Team divided the stretch into four segments. Each Sweeper used a canoe as a garbage barge (Figure 23). For one section, a jonboat was also used due to the large quantity of debris (Figure 24).

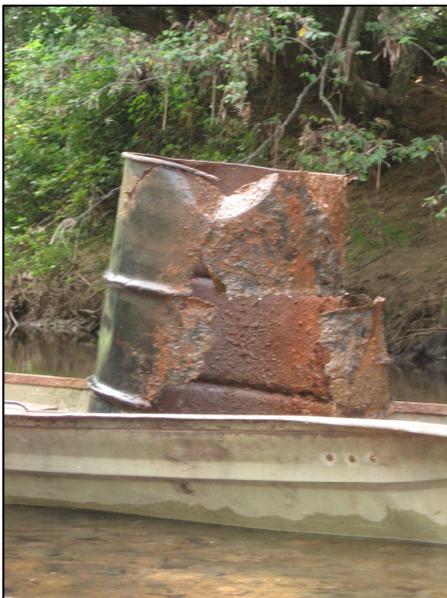
Figure 30 – Jonboat garbage barge

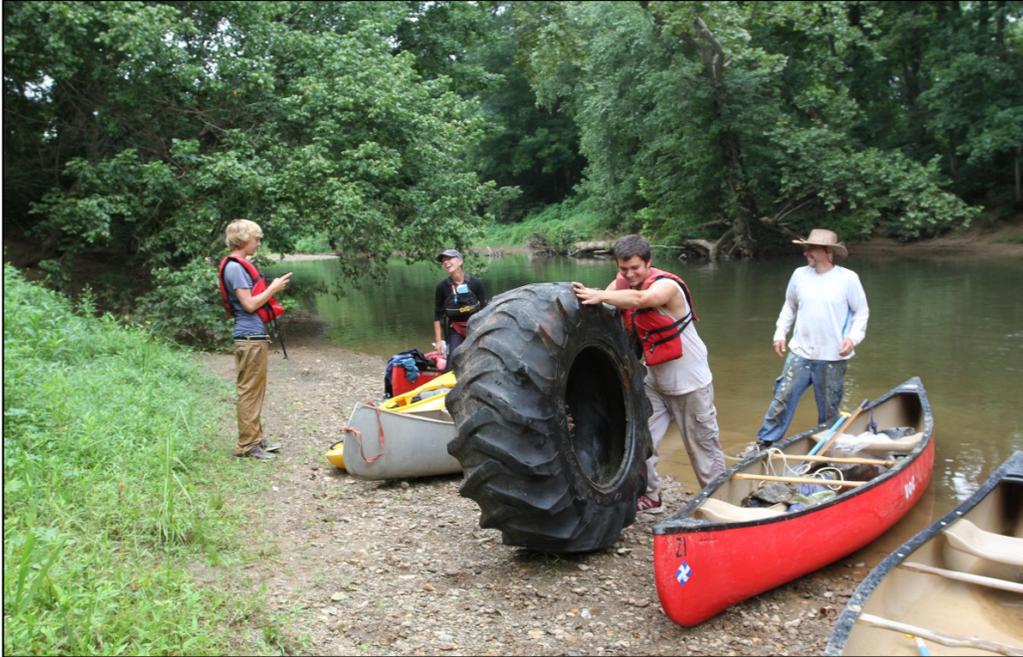
Figure 31 – Trash removal at access point

Every Sweeper was responsible for scanning the river bed and bank for trash. Whenever trash was spotted, a team member would secure his boat and pick up the trash and place it in the canoe. Most trash removal required team members to leave their canoes and enter the river. Many times a tire needed to be dug out of the river bank or bed. This required a few members of the crew to work together shoveling sediment from around the item in order to free it from the river. Upon arriving at each access point, Sweepers would remove trash from the boats and pile it up on the bank (Figure 25) . Canoes, paddles, etc. would be hauled up well away from the water ready for the next day's put in.

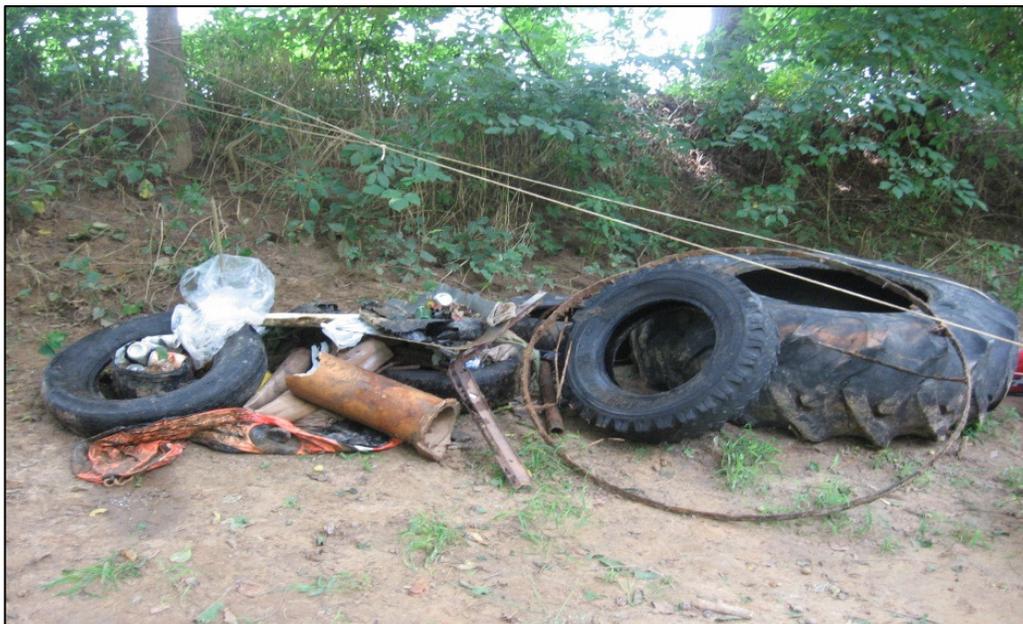
Figure 32 – Access Point 2 Trash

The 17 mile stretch of river contained many different types of trash. The material found most often was plastic. The majority of weight came from the numerous tires found.
